Bonded Fibre Reinforced Polymer Strengthening in a Real Fire

T.J. Stratford^{*}, M. Gillie, J.F. Chen and A.S. Usmani

Institute for Infrastructure and Environment, School of Engineering, The University of Edinburgh, UK.

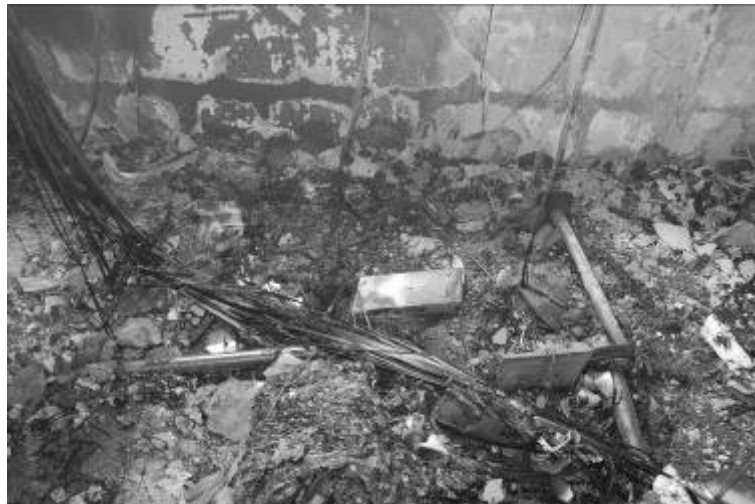
- The unprotected plate (Figure 9a) had completely separated from the concrete. Both the bonding adhesive and the matrix polymer had burnt away, leaving exposed concrete on the ceiling and a bundle of exposed fibres on the floor.

9(a) Remains of the unprotected plate (Test 1)

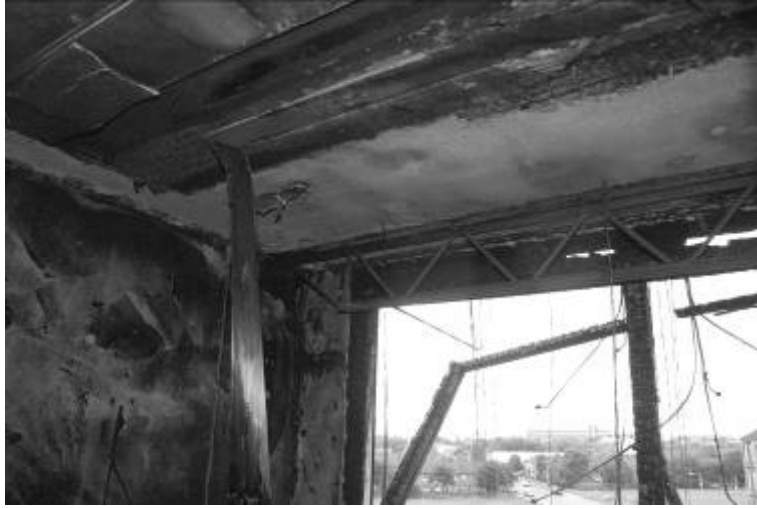
- The intumescent protected plate (Figure 9b) also separated from the concrete, except for a short length at its southern end, where it remained bonded to the concrete. Away from the southern end, the matrix polymer had burnt away to expose the fibres. The bonding adhesive that remained on the ceiling was charred. It should be noted that the gas phase temperatures show a cool region in the south west corner of the room. This is also evident in Figure 8 which shows less heat flux in the south.

9(b) Remains of the intumescent-protected plate (Test 1)

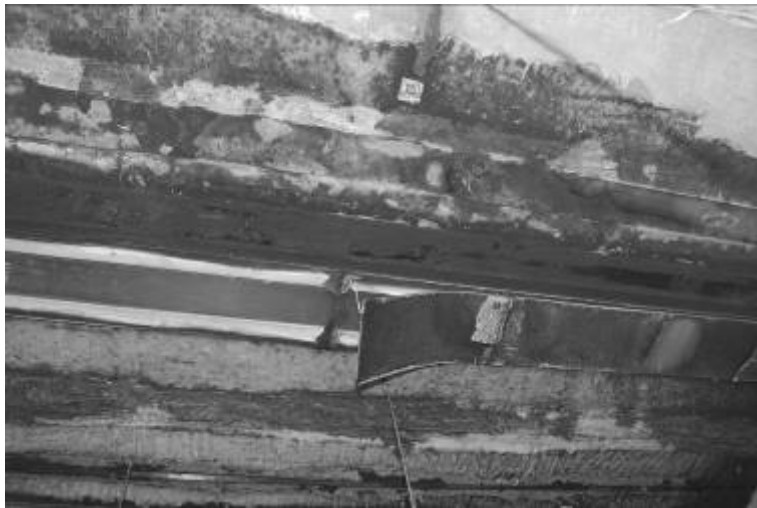
- The gypsum-board protection was fully intact after the tests, with no visible holes in the protection or signs that the fire had penetrated it. After the board was removed (Figure 9c), the plate was found to be fully bonded to the concrete, and there was no *visual* damage to either the plate or the adhesive.

9(c) Gypsum-board-protected plate, protection removed after fire to expose plate (Test 1)

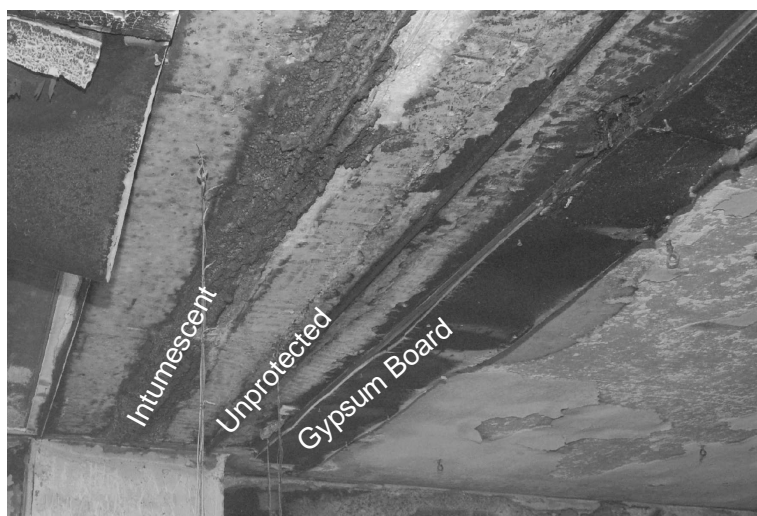
- The adhesive around the unprotected NSM bar (Figure 9d) had burnt away, leaving the FRP partially exposed, but the matrix polymer had not burnt away.

- The intumescent coating over the NSM strengthening (Figure 9d) had been activated. The strengthening beneath the intumescent was in place, although the adhesive was glazed and contained thin transverse cracks.

- The gypsum-board protected NSM (Figure 9d) remained intact, and the strengthening beneath was visually unaltered.

9(d) NSM strengthening after Test 1

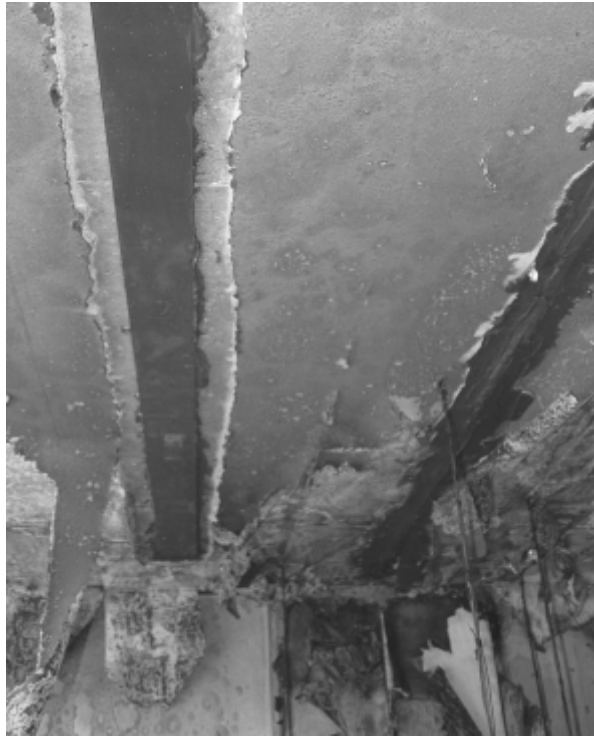
In Test 2 (the ‘Controlled Fire’), both the unprotected FRP plate and NSM strengthening were *visually* unaffected by the fire: the strengthening and adhesive remained in place, their colour had not changed, and there was no sign of crazing of the adhesive (Figure 9e). The FRP plate was easily removed by hand and the NSM was also removed with some assistance using hand tools. It was not possible to carry out mechanical tests to quantify the post-fire properties of the FRP components or the residual pull-off strength of the bonding adhesive after the fires.

9(e) The plate (left) and NSM (right) strengthening after Test 2

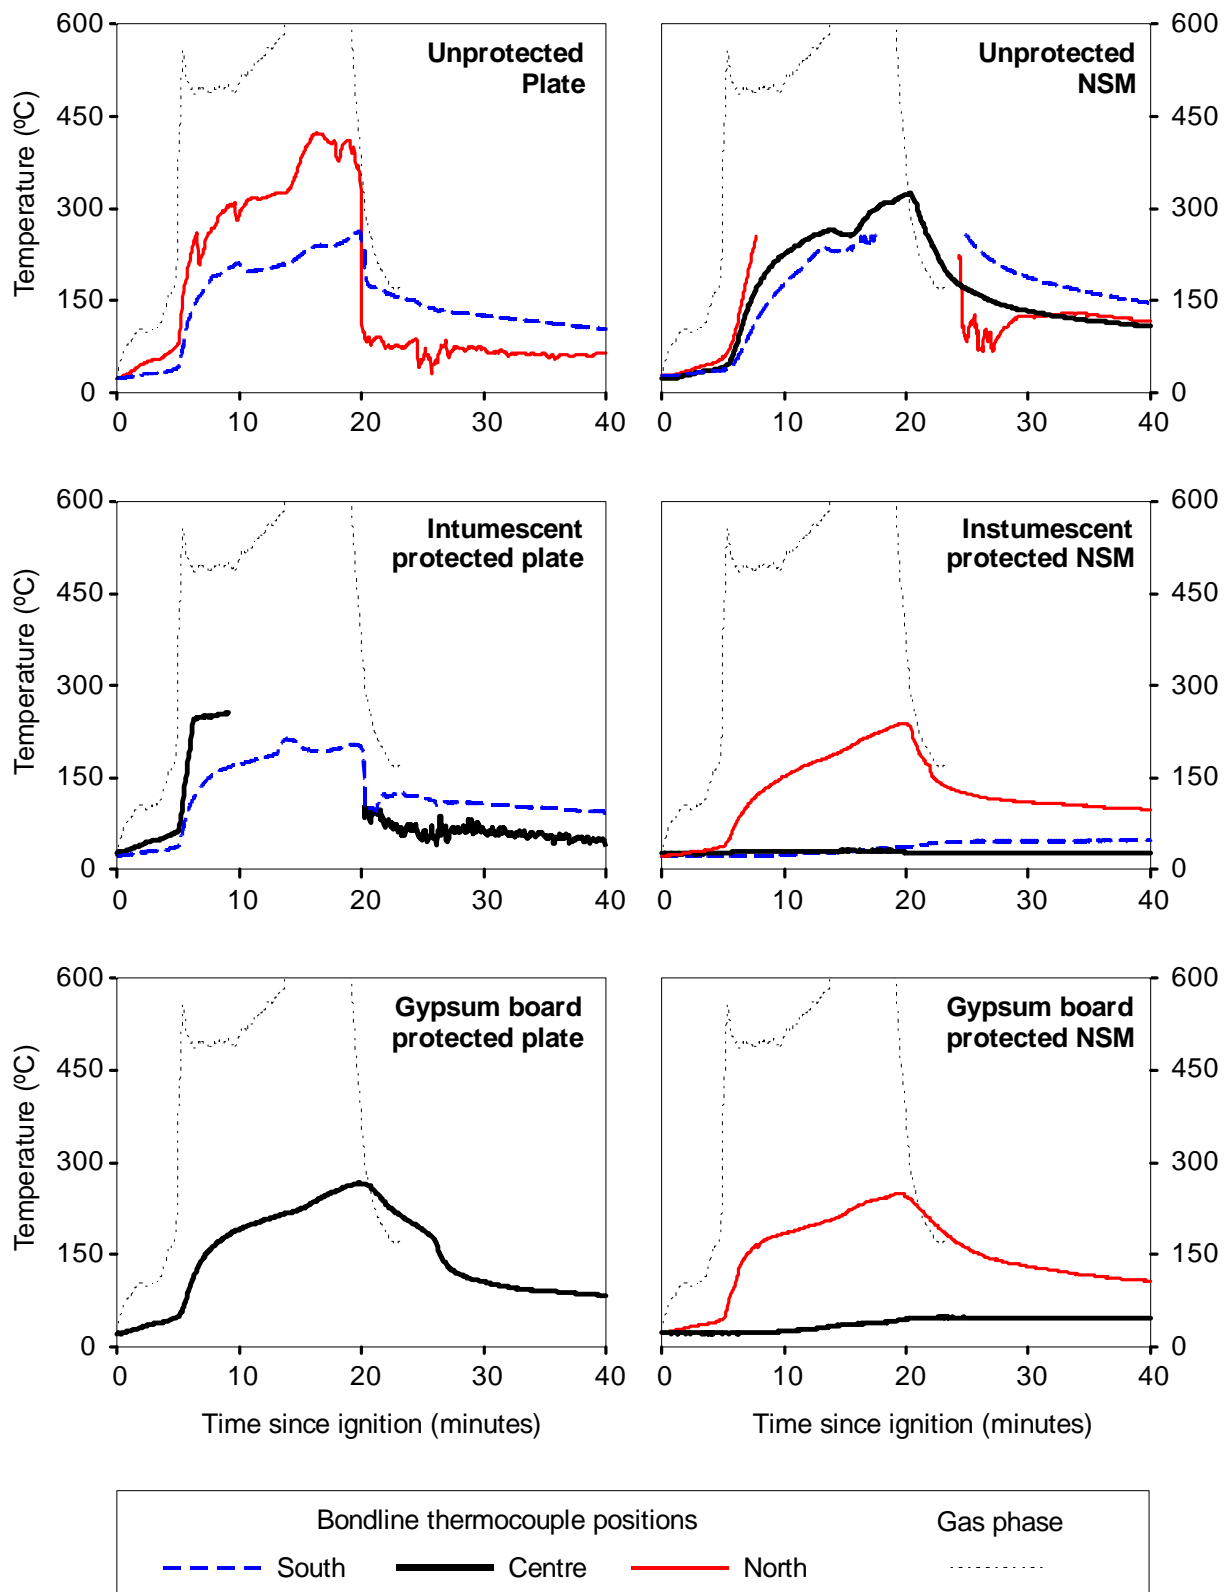
Figure 10: Bondline temperatures.

Figure 10 shows the temperatures recorded by the thermocouples in the FRP bondline for each type of strengthening and at each position (north, centre and south). A few thermocouples were inactive, probably due to broken wires. A further 3 thermocouples on NSM bars (gypsum-C, intumescent-N and intumescent-C) gave very low temperatures, and are also believed to have been faulty. The gas phase temperatures included in Figure 10 are from a single thermocouple near the ceiling slab in the centre of the strengthened region, but the wide variation in temperatures across the compartment should be noted (see Figure 7).

In all cases the bondline temperature rapidly exceeded the glass transition temperature of the adhesive. As expected, the bondline temperatures are highest in the unprotected plates, but even with gypsum-board protection, the glass transition temperature was reached less than a minute after flashover. The temperatures in the NSM bonding adhesive are comparable to the temperatures recorded in the plate bondlines, despite the NSM strengthening being embedded within the concrete (Figure 10).

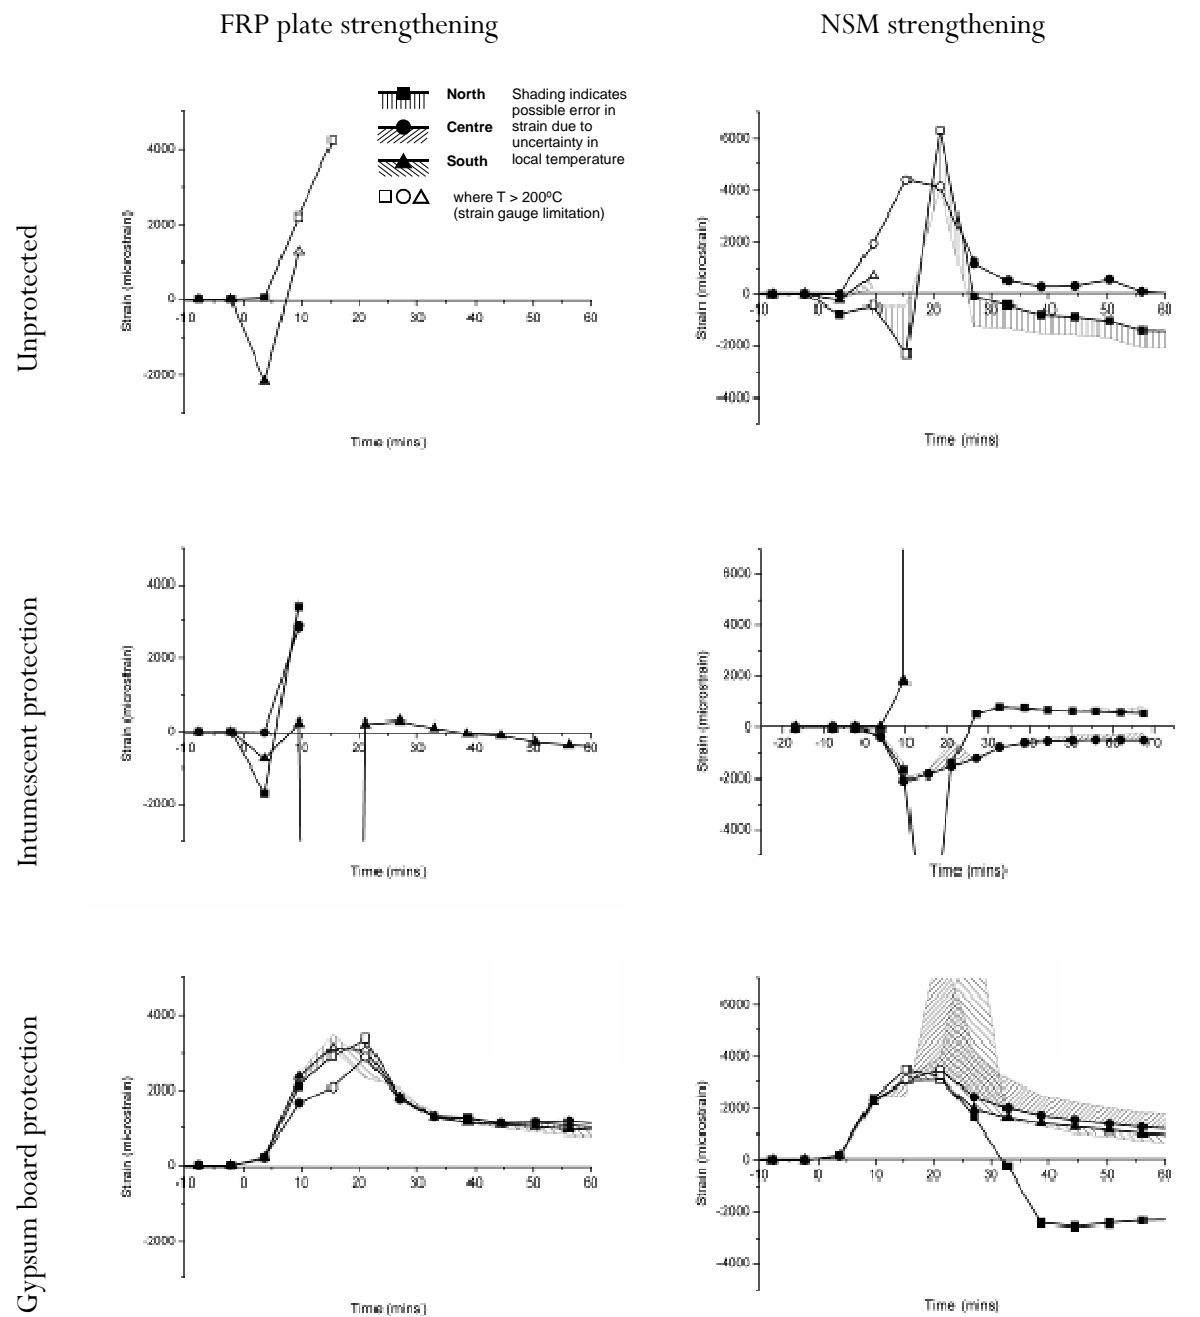
Figure 11: FRP strain measurements.

Despite the limitations of the strain gauge data, they are a useful indication of the performance of the strengthening. Separation of the intumescent painted FRP plate from the concrete, for example, occurred shortly after 10 minutes from the start of the test, but the plate remained in contact at the southern end (as observed in Figure 9b). The gypsum board protected strengthening systems have complete strain traces.
